# X-37 C/SiC Ruddervator Subcomponent Test Program

Larry Hudson and Craig Stephens  
NASA Dryden Flight Research Center  
Edwards, CA

2009 Annual Meeting  
September 29-October 1, 2009

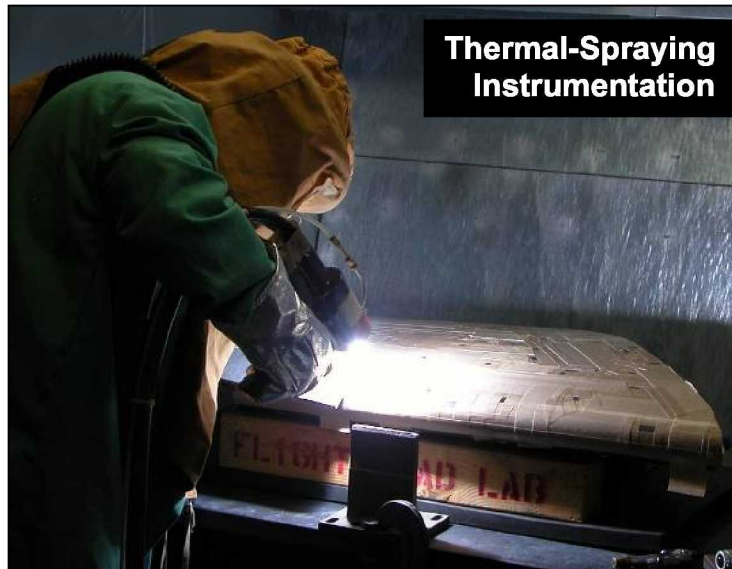
- Fiber optic strain sensors (15)
- Type-K thermocouples (74)

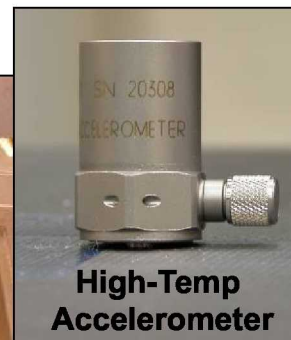
- **High-temperature modal survey instrumentation**
  - 14 high-temperature accelerometers (900°F limit)
  - High-temperature force transducer (400°F limit)

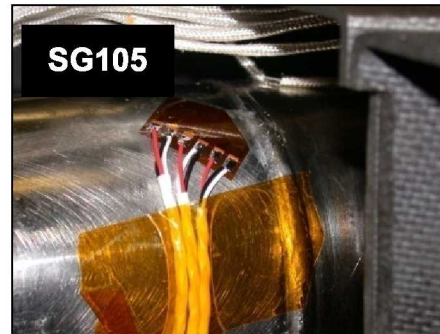
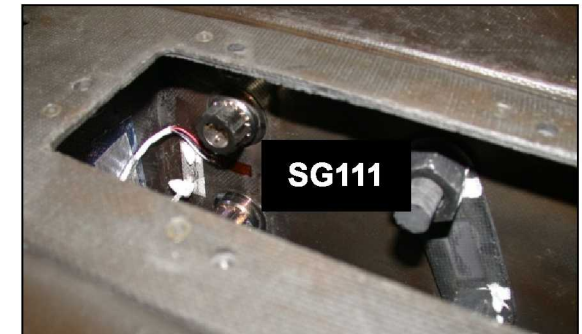
- **Foil strain gages (31)**
  - Leeward surface (12)
  - Windward surface (15)
  - Internal (1)
  - Spindle (3)
